Dairy-McKay Fish Passage Assessment and Prioritization

Washington County, Oregon
Department of Land Use and Transportation,
Operations and Maintenance Division

December 2006

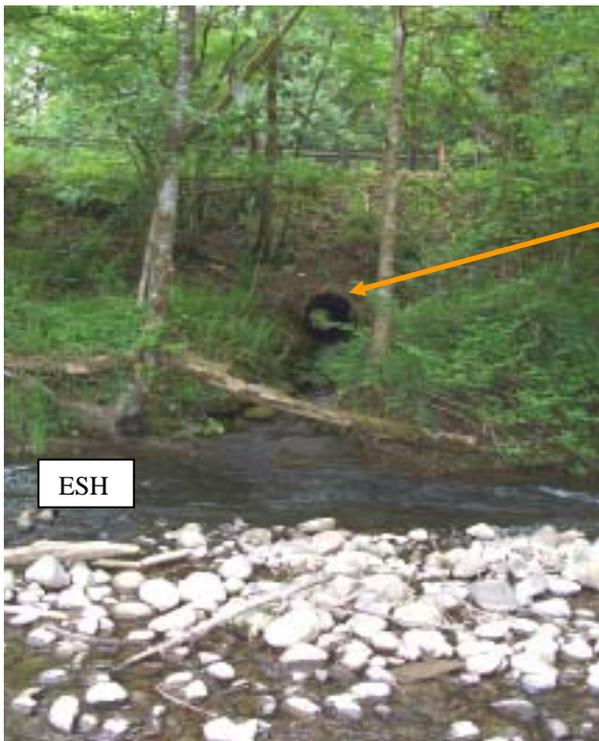
Example of barrier proximity to ESH. Culverts such as this block access to high quality refuge habitat and limit spawning and rearing access.

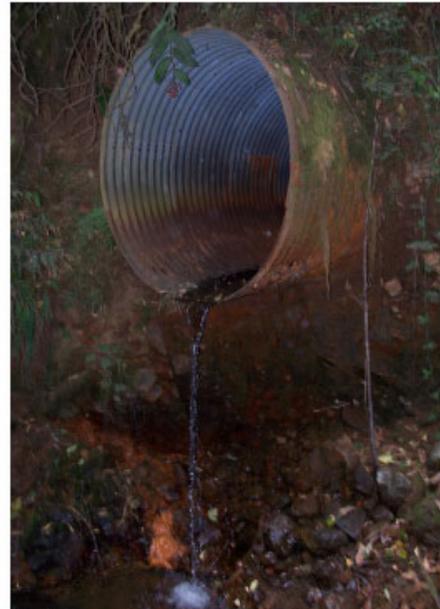
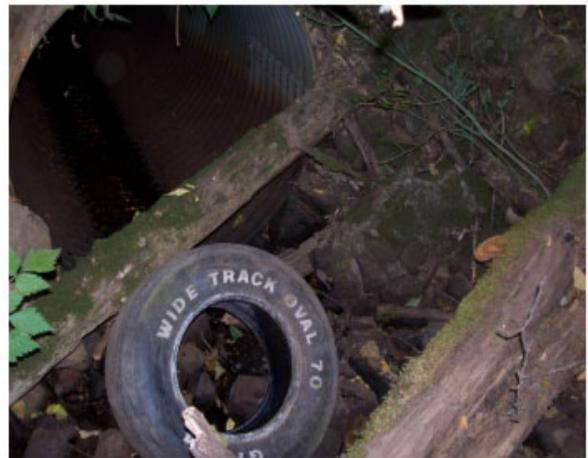
Culvert Location		Culvert Key #	340015FD3F	Group	1
Road Name	Nowakowski Rd				
Mile Post	1.319				
Watershed	Dairy McKay				
Stream Name	Tributary to West Fork Dairy Creek				
Latitude	45deg44.197'N				
Longitude	123deg12.195'				
Culvert Key #	340015FD3F				
County Asset #	1849				
Culvert Information					
Shape	Circular				
Material	Corrugated Steel				
Length (ft)	114				
Width (ft)	4				
Height (ft)	4				
Outlet Perch (ft)	4.7				
Slope	2.01%				
Channel Information					
Upstream Gradient	3.25%				
Bankfull width (ft)	8.00				
Prioritization Analysis					
Habitat Length (mi)	1.814				
Habitat Quality	8.6				
Barrier Severity	3				
Distance to ESH (mi)	0.63				
Habitat Length Points	4				
Habitat Quality Points	4				
Barrier Points	3				
ESH Points	0.92				
Total Points:	11.92

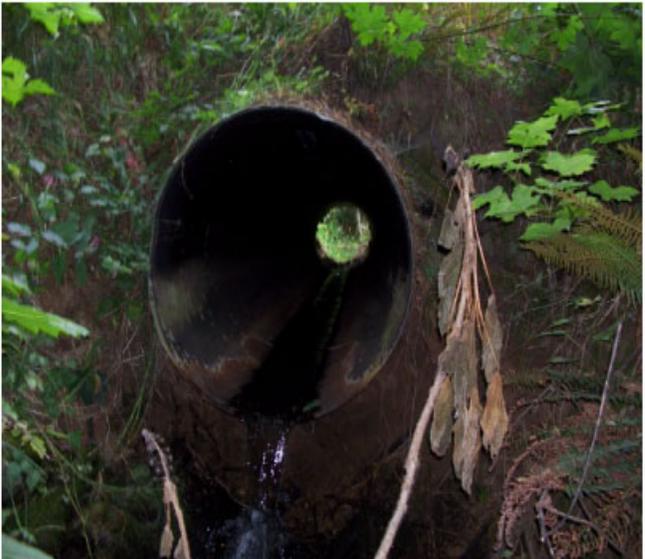
Culvert Location		Culvert Key #	340015FD3F	Group	1
Road Name	Genzer Rd

Mile Post	1.088				
Watershed	Dairy McKay				
Stream Name	Genzer Creek				
Latitude	45deg44.489'N				
Longitude	123deg10.394'W				
Culvert Key #	340015FEC6				
County Asset #	1868				
Culvert Information					
Shape	Circular				
Material	Corrugated Steel				
Length (ft)	39				
Width (ft)	4				
Height (ft)	4				
Outlet Perch (ft)	3				
Slope	2.95%				
Channel Information					
Stream Gradient	3.00%				
Bankfull width (ft)	9.5				
Prioritization Analysis					
Habitat Length (mi)	3.685				
Habitat Quality	8.4				
Barrier Severity	3				
Distance to ESH (mi)	1.378				
Habitat Length Points	4				
Habitat Quality Points	4				
Barrier Points	3				
ESH Points	0.824				
Total Points:	11.82

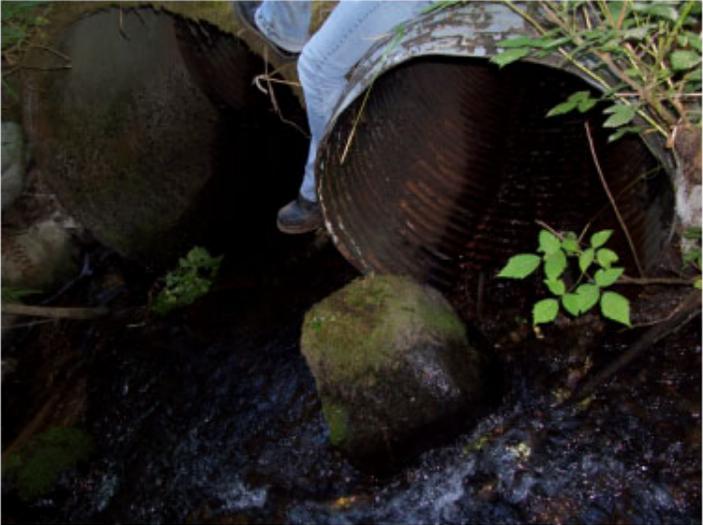
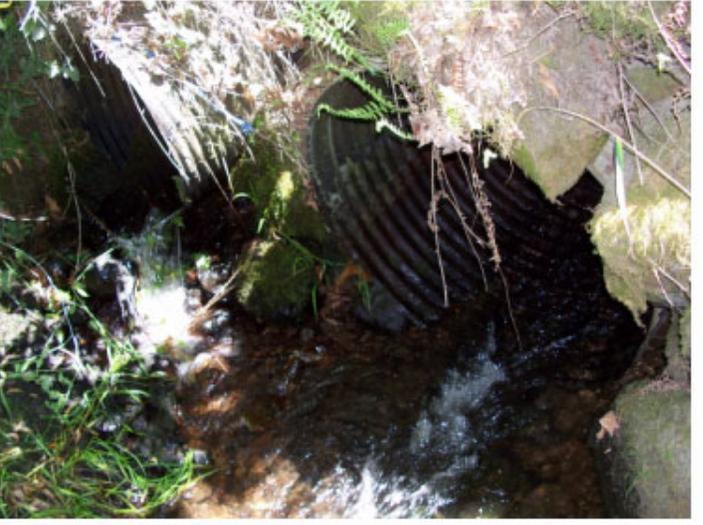
Culvert Location		Culvert Key #	340016011A	Group	2
Road Name	Greener Rd

Mile Post	1.165, 1.166				
Watershed	Dairy McKay				
Stream Name	Rock Creek				
Latitude	45deg44.392'N				
Longitude	123deg03.313'W				
Culvert Key #	340016011A				
County Asset #	1651				
Culvert Information					
Shape	Circular

Material	Corrugated Steel				
Length (ft)	30				
Width (ft)	4, 3				
Height (ft)	4, 3				
Outlet Perch (ft)	0, 1.2				
Slope	9.17%, 4.65%				
Channel Information					
Upstream Gradient	2%				
Bankfull width (ft)	12.5				
Prioritization Analysis					
Habitat Length (mi)	4.67				
Habitat Quality	8				
Barrier Severity	2				
Distance to ESH (mi)	0.97				
Habitat Length Points	4				
Habitat Quality Points	4				
Barrier Points	2				
ESH Points	0.875				
Total Points:	10.88

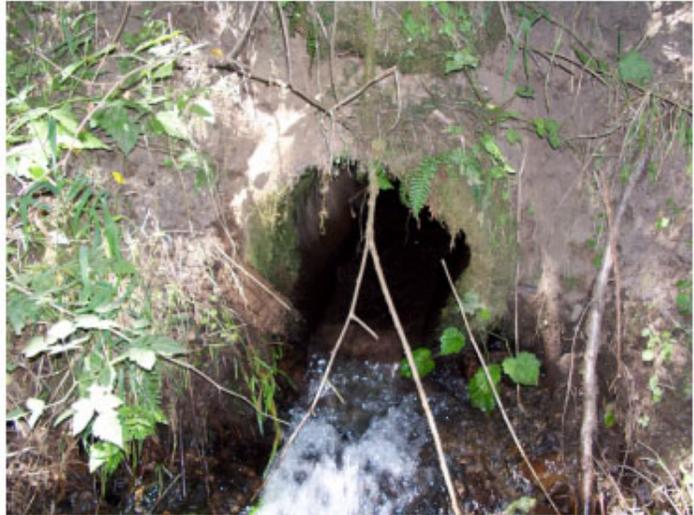
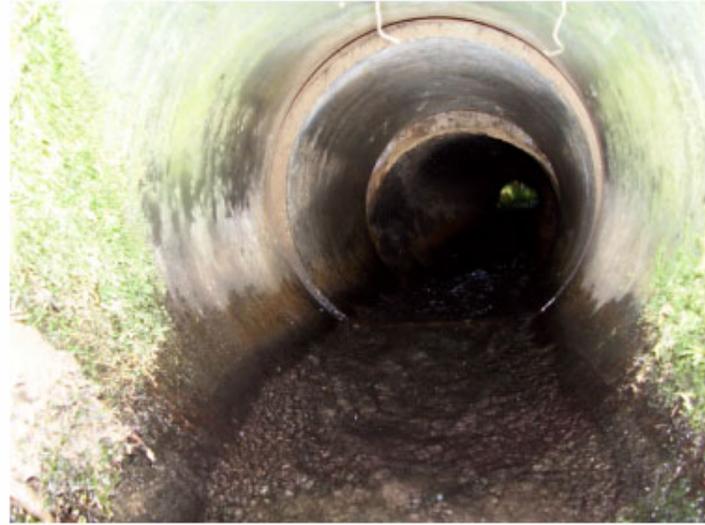
Culvert Location		Culvert Key #	340016011D	Group	2
Road Name	Greener Rd

Mile Post	1.425				
Watershed	Dairy McKay				
Stream Name	Tributary of Rock Creek				
Latitude	45deg44.581'N				
Longitude	123deg03.155'W				
Culvert Key #	340016011D				
County Asset #					
Culvert Information					
Shape	Circular				
Material	Corrugated Steel				
Length (ft)	37				
Width (ft)	2				
Height (ft)	2				
Outlet Perch (ft)	0.5				
Slope	7.84%				
Channel Information					
Upstream Gradient	11%				
Bankfull width (ft)	6.25				
Prioritization Analysis					
Habitat Length (mi)	0.17				
Habitat Quality	7.6				
Barrier Severity	4				
Distance to ESH (mi)	1.2				
Habitat Length Points	1				
Habitat Quality Points	4				
Barrier Points	4				
ESH Points	0.84				
Total Points:	9.84

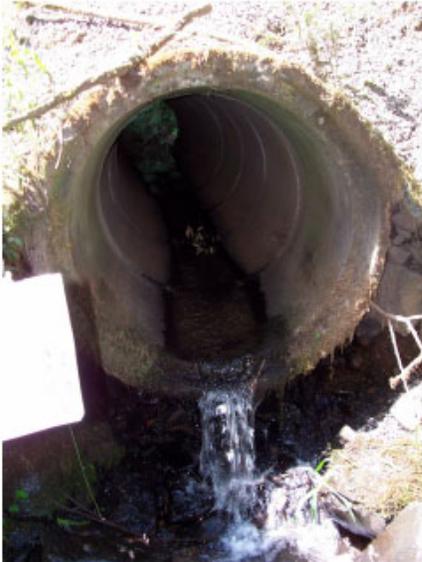
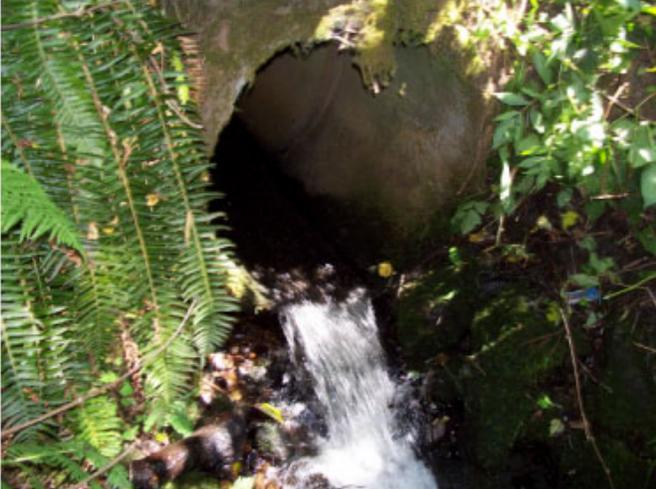
Culvert Location		Culvert Key #	340016011E	Group	2
Road Name	Greener Rd

Mile Post	2.659				
Watershed	Dairy McKay				
Stream Name	Panther Creek				
Latitude	45deg45.258'N				
Longitude	123deg02.779'W				
Culvert Key #	340016011E				
County Asset #	1898				
Culvert Information					
Shape	Circular				
Material	Corrugated Steel				
Length (ft)	31				
Width (ft)	3				
Height (ft)	3				
Outlet Perch (ft)	0.58				
Slope	10.94%				
Channel Information					
Upstream Gradient	4%				
Bankfull width (ft)	9				
Prioritization Analysis					
Habitat Length (mi)	2.873				
Habitat Quality	6				
Barrier Severity	3				
Ditance to ESH (mi)	1.2				
Habitat Length Points	4				
Habitat Quality Points	3				
Barrier Points	3				
ESH Points	0.79				
Total Points:	10.79

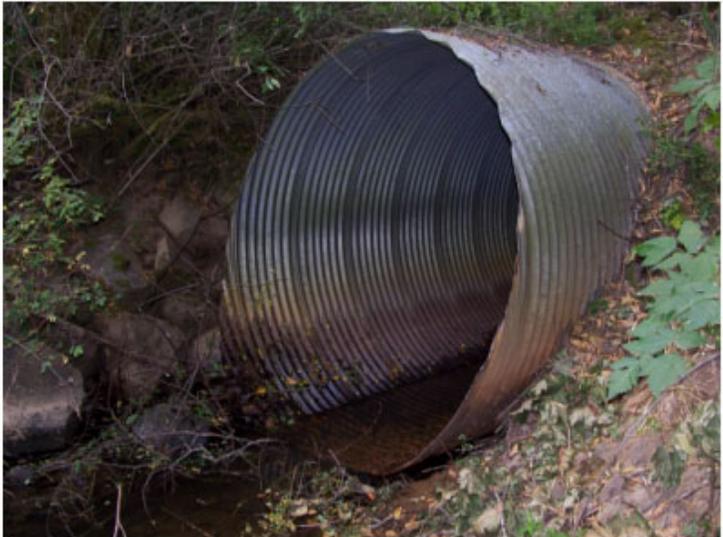
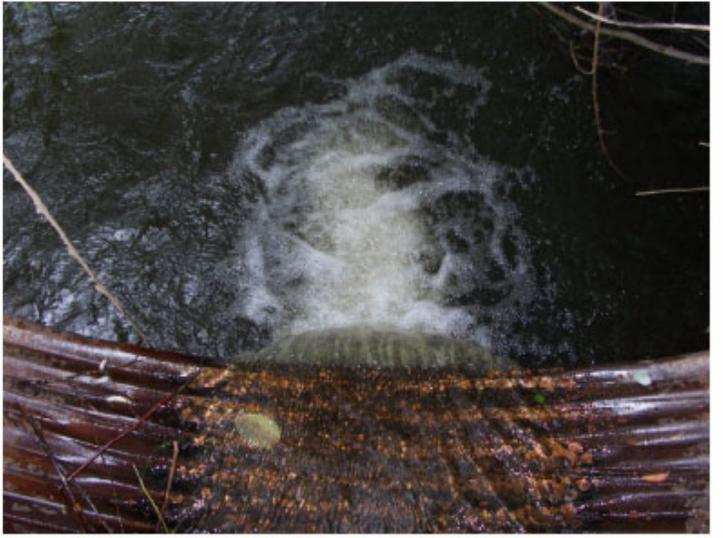
Culvert Location		Culvert Key #	34001600F7	Group	3
Road Name	Sullivan Rd

Mile Post	0.042				
Watershed	Dairy McKay				
Stream Name	Burgholzer Creek				
Latitude	45deg41.175'N				
Longitude	123deg12.477'W				
Culvert Key #	340015FD7F				
County Asset #	1852				
Culvert Information					
Shape	Circular				
Material	Corrugated Steel				
Length (ft)	61				
Width (ft)	8.33				
Height (ft)	8.33				
Outlet Perch (ft)	0.108				
Slope	0.11%				
Channel Information					
Upstream Gradient	1%				
Bankfull width (ft)	13				
Prioritization Analysis					
Habitat Length (mi)	7.789				
Habitat Quality	7.5				
Barrier Severity	1				
Distance to ESH (mi)	0.0				
Habitat Length Points	4				
Habitat Quality Points	4				
Barrier Points	1				
ESH Points	1.0				
Total Points:	10.0

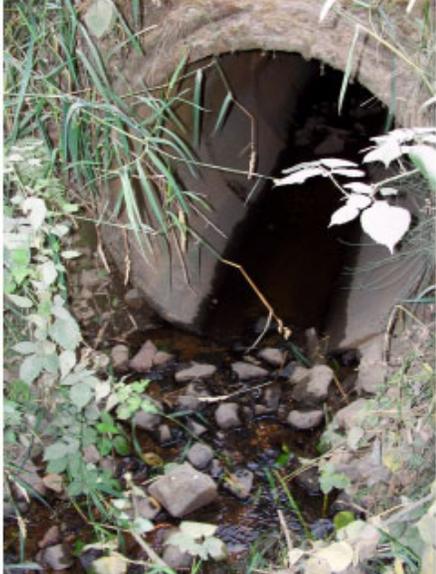
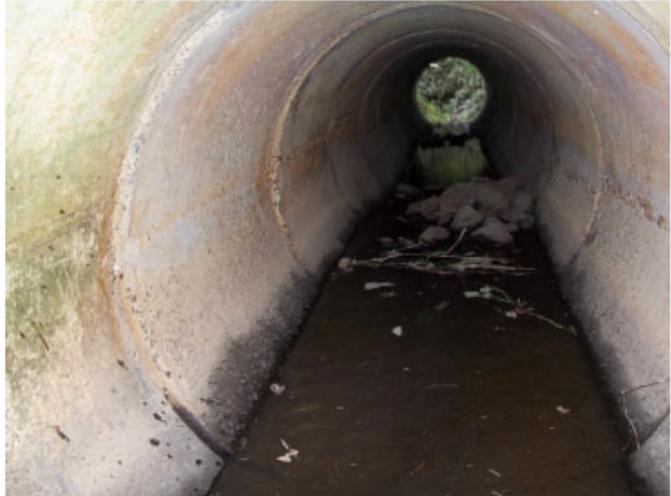
Culvert Location		Culvert Key #	340015FD59	Group	3
Road Name	Strassel Rd

Mile Post	0.592				
Watershed	Dairy McKay				
Stream Name	Poliwaski Canyon Creek				
Latitude	45deg41.391'N				
Longitude	123deg12.820'W				
Culvert Key #	340015FD59				
County Asset #	1658				
Culvert Information					
Shape	Circular

Material	Precast Concrete				
Length (ft)	44				
Width (ft)	4				
Height (ft)	4				
Outlet Perch (ft)	0				
Slope	1.45%				
Channel Information					
Upstream Gradient	2%				
Bankfull width (ft)	7				
Prioritization Analysis					
Habitat Length (mi)	2.006				
Habitat Quality	7.5				
Barrier Severity	1				
Distance to ESH (mi)	0.1				
Habitat Length Points	4				
Habitat Quality Points	4				
Barrier Points	1				
ESH Points	0.98				
Total Points:	9.98

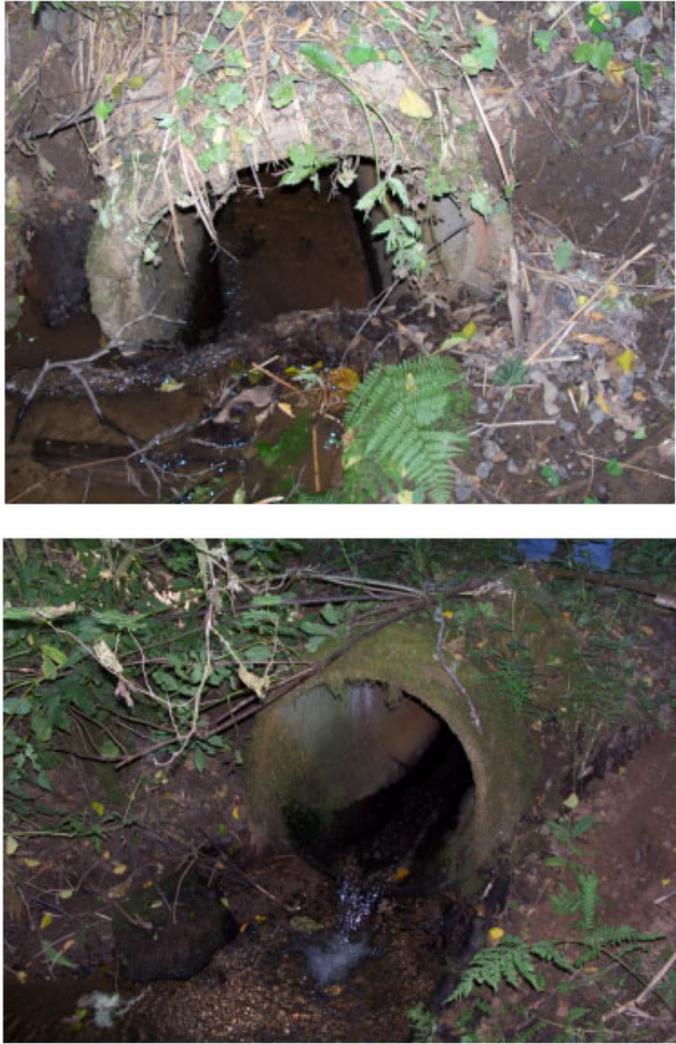
Culvert Location		Culvert Key #	340015FE4F	Group	4
Road Name	Leyman Rd

The Leyman Road barriers are close together and would be easy to replace at the same time. Providing access to 1.5 miles of upstream habitat, these two culverts are impassable at all flows.

Mile Post	0.241				
Watershed	Dairy McKay				
Stream Name	Tributary of Whitcher Creek				
Latitude	45deg42.846'N				
Longitude	123deg08.343'W				
Culvert Key #	340015FE4F				
County Asset #	1871				
Culvert Information					
Shape	Circular				
Material	Precast Concrete				
Length (ft)	44				
Width (ft)	3				
Height (ft)	3				
Outlet Perch (ft)	0.5				
Slope	3.16%				
Channel Information					
Upstream Gradient	3%				
Bankfull width (ft)	6.25				
Prioritization Analysis					
Habitat Length (mi)	0.597				
Habitat Quality	8.5				
Barrier Severity	4				
Distance to ESH (mi)	1.0				
Habitat Length Points	2				
Habitat Quality Points	4				
Barrier Points	4				
ESH Points	0.9				
Total Points:	10.87

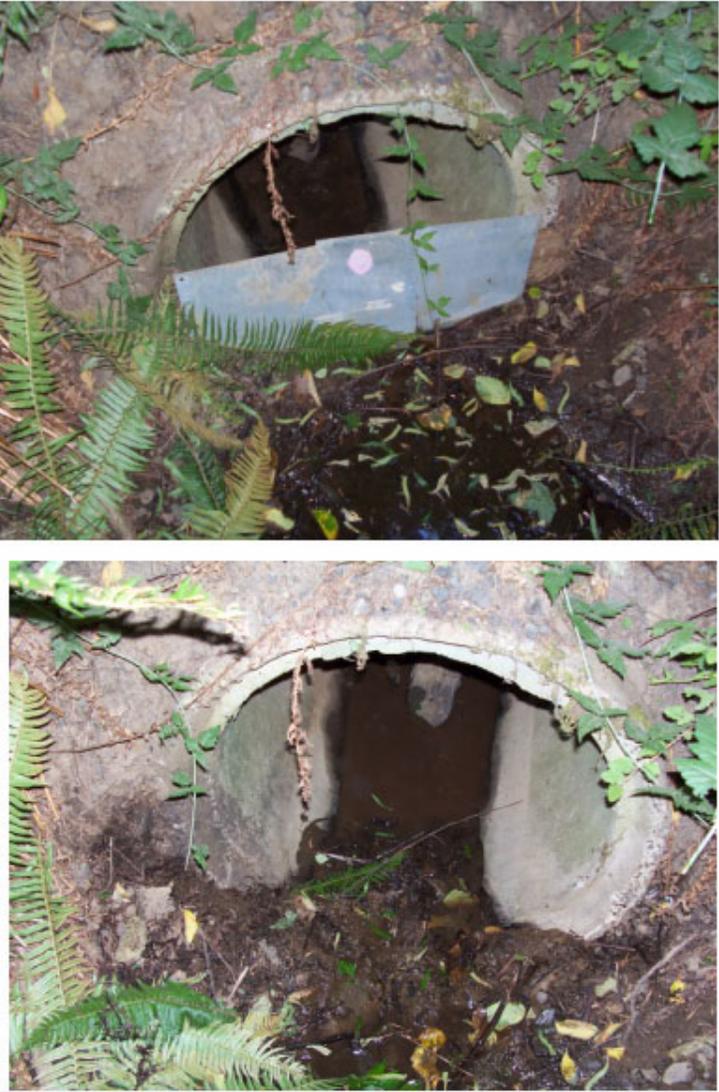
Culvert Location		Culvert Key #	340015FE51	Group	4
<i>Road Name</i>	Leyman Rd

<i>Mile Post</i>	0.584				
<i>Watershed</i>	Dairy McKay				
<i>Stream Name</i>	Whitcher Creek				
<i>Latitude</i>	45deg42.951'N				
<i>Longitude</i>	123deg08.508'N				
<i>Culvert Key #</i>	340015FE51				
<i>County Asset #</i>					
Culvert Information					
<i>Shape</i>	Circular				
<i>Material</i>	Precast Concrete				
<i>Length (ft)</i>	28				
<i>Width (ft)</i>	2.5				
<i>Height (ft)</i>	2.5				
<i>Outlet Perch (ft)</i>	0.75				
<i>Slope</i>	4.86%				
Channel Information					
<i>Upstream Gradient</i>	8%				
<i>Bankfull width (ft)</i>	7				
Prioritization Analysis					
<i>Habitat Length (mi)</i>	0.861				
<i>Habitat Quality</i>	7.8				
<i>Barrier Severity</i>	3				
<i>Distance to ESH (mi)</i>	1.0				
<i>Habitat Length Points</i>	2				
<i>Habitat Quality Points</i>	4				
<i>Barrier Points</i>	3				
<i>ESH Points</i>	0.87				
Total Points:	9.87

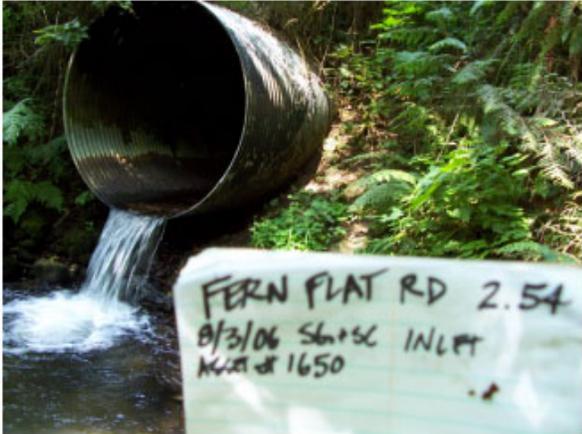
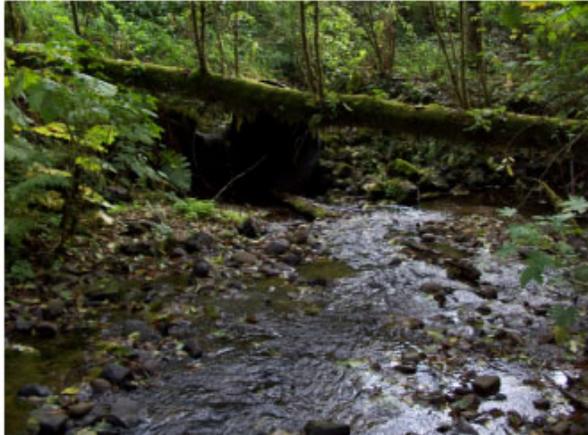
Fern Flat Road Culvert

Mile Post	2.54				
Watershed	Dairy McKay				
Stream Name	Campbell Creek				
Latitude	45deg45.347'N				
Longitude	123deg04.557'W				
Culvert Key #	34001600F7				
County Asset #	1650				
Culvert Information					
Shape	Circular				
Material	Corrugated Steel				
Length (ft)	61				
Width (ft)	7				
Height (ft)	7				
Outlet Perch (ft)	2.58				
Slope	4.13%				
Channel Information					
Upstream Gradient	4%				
Bankfull width (ft)	18				
Prioritization Analysis					
Habitat Length (mi)	5.189				
Habitat Quality	9.4				
Barrier Severity	3				
Distance to ESH (mi)	0.0				
Habitat Length Points	4				
Habitat Quality Points	4				
Barrier Points	3				
ESH Points	1.0				
Total Points:	12.0

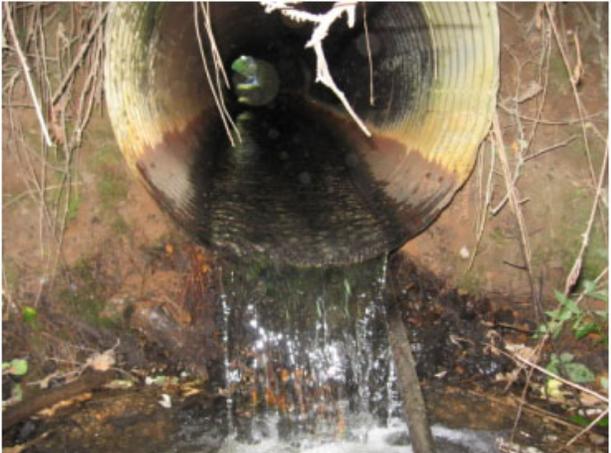
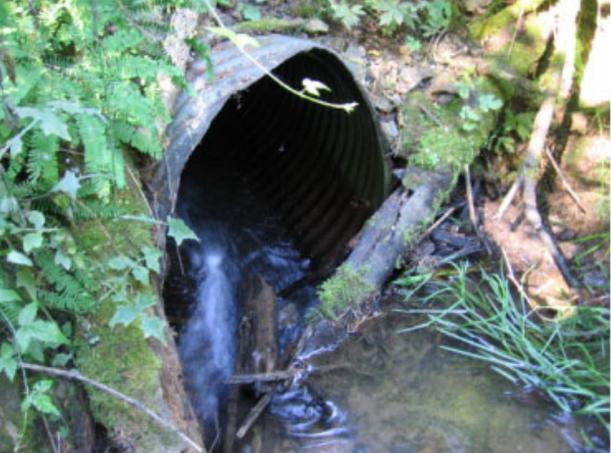
Kay Road Culvert

The Kay Road culvert at milepost 0.228 carries Neil Creek. Replacing this barrier will connect the upper section of Neil Creek to McKay Creek.

Mile Post	0.228				
Watershed	Dairy McKay				
Stream Name	Neil Creek				
Latitude	45deg39.549'N				
Longitude	122deg58.705'W				
Culvert Key #	3400160162				
County Asset #	1902				
Culvert Information

Shape	Circular				
Material	Corrugated Steel				
Length (ft)	60				
Width (ft)	3				
Height (ft)	3				
Outlet Perch (ft)	1.21				
Slope	1.55%				
Channel Information					
Upstream Gradient	2%				
Bankfull width (ft)	7				
Prioritization Analysis					
Habitat Length (mi)	2.099				
Habitat Quality	6.9				
Barrier Severity	3				
Distance to ESH (mi)	0.61				
Habitat Length Points	4				
Habitat Quality Points	3				
Barrier Points	3				
ESH Points	0.92				
Total Points:	10.92

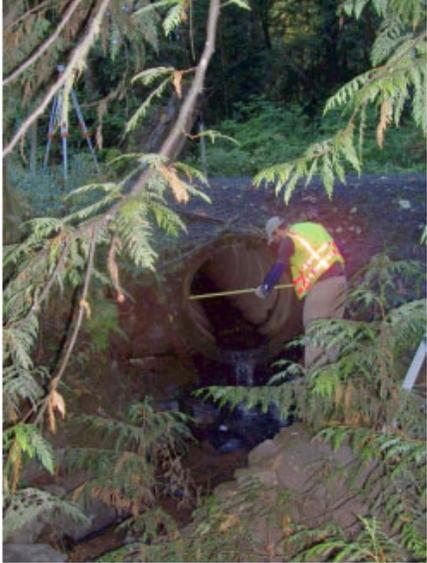
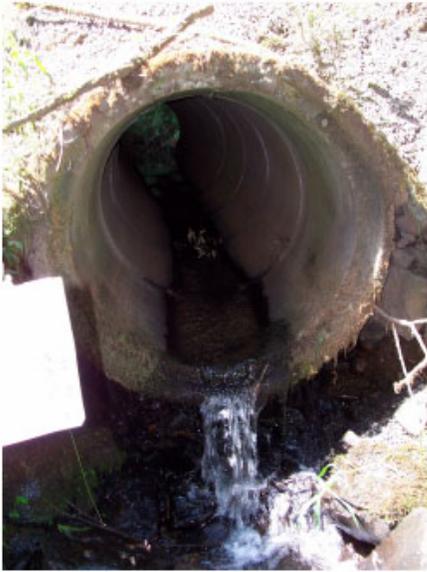
Keller Road Culvert

The culvert at milepost 0.59 on Keller Road carries Gumm Creek which eventually flows into the East Fork of Dairy Creek. Washington County has replaced two culverts downstream on the Gumm Creek system, so replacing the Keller Road culvert would serve to further link the system.

Mile Post	0.59				
Watershed	Dairy McKay				
Stream Name	Gumm Creek				
Latitude	45deg39.460'N				
Longitude	123deg02.276'W				
Culvert Key #	34001600A2				
County Asset #	1647				
Culvert Information					
Shape	Circular				
Material	Precast Concrete				
Length (ft)	30				
Width (ft)	3.5				
Height (ft)	3.5				
Outlet Perch (ft)	1.5				
Slope	0.00%				
Channel Information					
Upstream Gradient	2%				
Bankfull width (ft)	5.25				
Prioritization Analysis					
Habitat Length (mi)	1.872				
Habitat Quality	7.9				
Barrier Severity	2				
Distance to ESH (mi)	2.78				
Habitat Length Points	4				
Habitat Quality Points	4				
Barrier Points	2				
ESH Points	0.64				
Total Points:	10.64

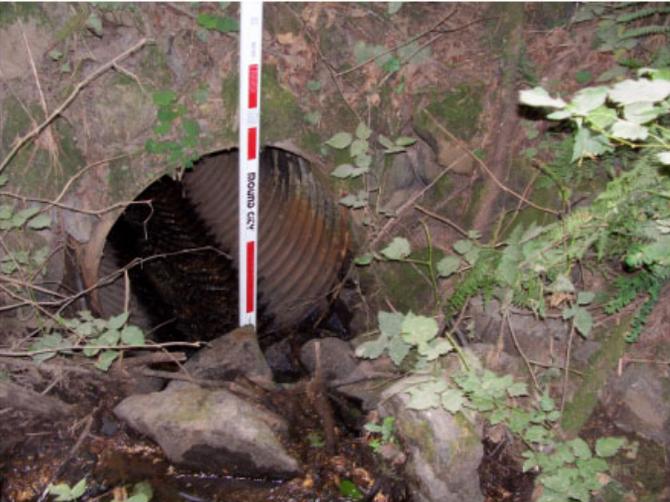
Gheen Road Culvert

The culvert at milepost 0.124 on Gheen Road carries Kuder Creek and would provide access to 1.3 miles of habitat if replaced.

Mile Post	0.124				
Watershed	Dairy McKay				
Stream Name	Kuder Creek				
Latitude	45deg39.859'N				
Longitude	123deg11.516'W				
Culvert Key #	340015FECA				
County Asset #	1869				
Culvert Information					
Shape	Circular				
Material	Corrugated Steel				
Length (ft)	40				
Width (ft)	3				
Height (ft)	3				
Outlet Perch (ft)	0				
Slope	2.95%				
Channel Information					
Upstream Gradient	2%				
Bankfull width (ft)	6.75				
Prioritization Analysis					
Habitat Length (mi)	1.269				
Habitat Quality	7.8				
Barrier Severity	2				
Distance to ESH (mi)	2.01				
Habitat Length Points	3				
Habitat Quality Points	4				
Barrier Points	2				
ESH Points	0.74				
Total Points:	9.74

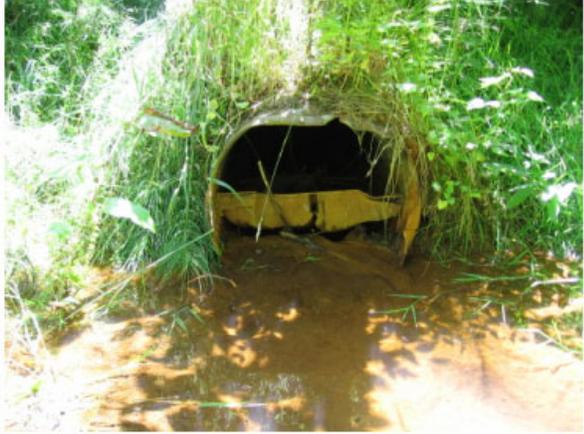
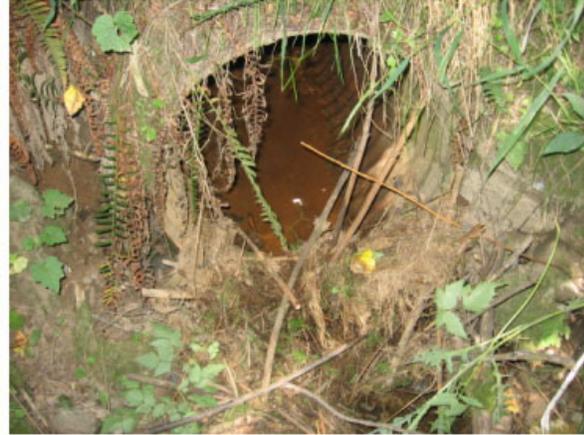
Dixie Mountain Road Culvert

Mile Post	3.132								
Watershed	Dairy McKay								
Stream Name	Tributary of Neil Creek								
Latitude	45deg41.060'N								
Longitude	122deg58.073'W								
Culvert Key #	3400160198								
County Asset #									
Culvert Information

Shape	Circular								
Material	Corrugated Steel								
Length (ft)	72								
Width (ft)	2								
Height (ft)	2								
Outlet Perch (ft)	1								
Slope	4.00%								
Channel Information									
Upstream Gradient	1%								
Bankfull width (ft)	2.5								
Prioritization Analysis									
Habitat Length (mi)	0.201								
Habitat Quality	7.5								
Barrier Severity	4								
Distance to ESH (mi)	2.7								
Habitat Length Points	1								
Habitat Quality Points	4								
Barrier Points	4								
ESH Points	0.66								
Total Points:	9.66

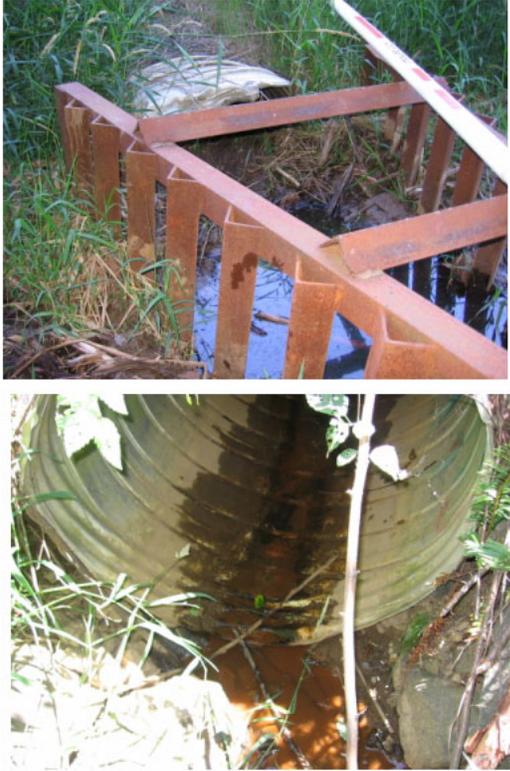
Hansen Road Culvert

The culvert at milepost 0.519 on Hansen Road will not be immediately pursued due to social issues surrounding the area.

Mile Post	0.519				
Watershed	Dairy McKay				
Stream Name	Tributary of East fork of McKay Creek				
Latitude	46deg41.400' N				
Longitude	122deg56.355' W				
Culvert Key #	340016016B				
County Asset #	1903				
Culvert Information					
Shape	Circular				
Material	Corrugated Aluminum				
Length (ft)	40				
Width (ft)	4				
Height (ft)	4				
Outlet Perch (ft)	0.083				
Slope	9.52%				
Channel Information					
Upstream Gradient	1%				
Bankfull width (ft)	5.5				
Prioritization Analysis					
Habitat Length (mi)	0.633				
Habitat Quality	8.2				
Barrier Severity	3				
Distance to ESH (mi)	2.7				
Habitat Length Points	2				
Habitat Quality Points	4				
Barrier Points	3				
ESH Points	0.66				
Total Points:	9.66

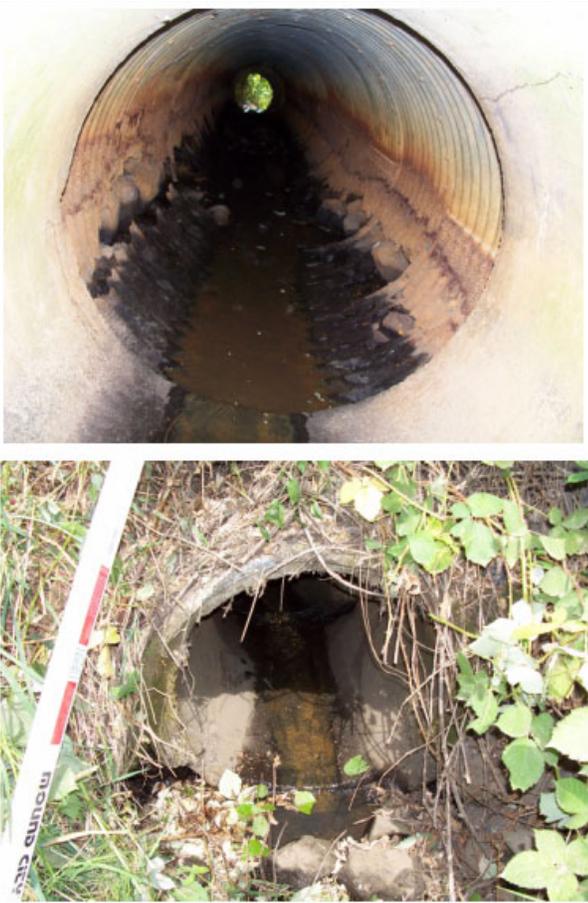
Hahn Road Culvert

The culvert at milepost 0.328 on Hahn Road is in very poor structural condition with a remaining design life of approximately 5 years. Washington County replaces all culverts on fish bearing streams to fish passage standards; when replaced the project will provide access to 2.1 miles of upstream habitat.

Mile Post	0.328								
Watershed	Dairy McKay								
Stream Name	Wirtz Branch Creek								
Latitude	45deg37.626'N								
Longitude	123deg02.919'W								
Culvert Key #	340015FE89								
County Asset #	1903								
Culvert Information									
Shape	Circular								
Material	Corrugated Steel								
Length (ft)	34								
Width (ft)	2.5								
Height (ft)	2.5								
Outlet Perch (ft)	0.04								
Slope	2.41%								
Channel Information									
Upstream Gradient	1%								
Bankfull width (ft)	5.5								
Prioritization Analysis									
Habitat Length (mi)	2.137								
Habitat Quality	5								
Barrier Severity	2								
Distance to ESH (mi)	3.3								
Habitat Length Points	4								
Habitat Quality Points	3								
Barrier Points	2								
ESH Points	0.58								
Total Points:	9.58

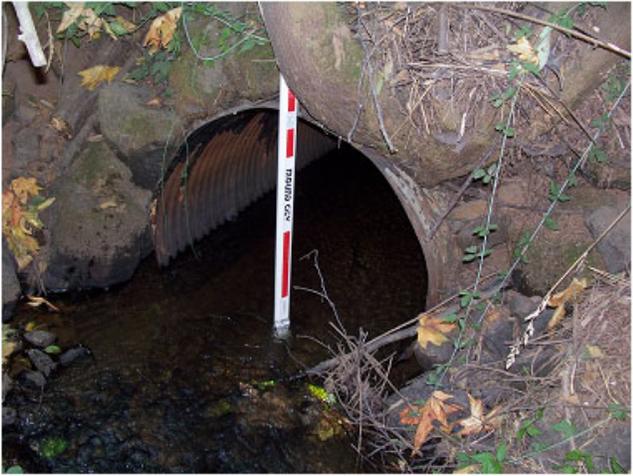
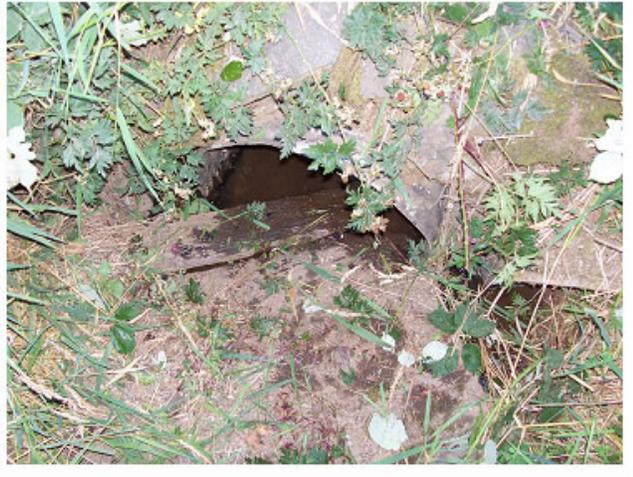
Narup Road Culvert

The culvert at milepost 0.837 on Narup Road carries Sadd Creek, an ESH stream, and would provide access to 6.2 miles of upstream habitat if replaced. Although it is only a partial barrier, replacing this culvert would open up significant fish habitat to multiple species and life histories.

Mile Post	0.837								
Watershed	Dairy McKay								
Stream Name	Sadd Creek								
Latitude	45deg37.289'N								
Longitude	123deg10.840'N								
Culvert Key #	340015FE12								
County Asset #	1818								
Culvert Information

Shape	Circular								
Material	Corrugated Steel								
Length (ft)	62								
Width (ft)	4								
Height (ft)	4								
Outlet Perch (ft)	0								
Slope	0.00%								
Channel Information									
Upstream Gradient	1%								
Bankfull width (ft)	8.5								
Prioritization Analysis									
Habitat Length (mi)	6.243								
Habitat Quality	5.9								
Barrier Severity	1								
Distance to ESH (mi)	0.0								
Habitat Length Points	4								
Habitat Quality Points	3								
Barrier Points	1								
ESH Points	1.0								
Total Points:	9.0

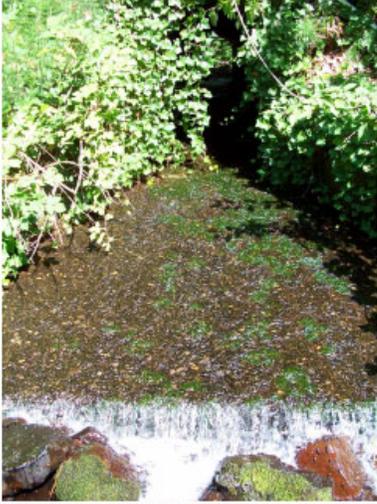
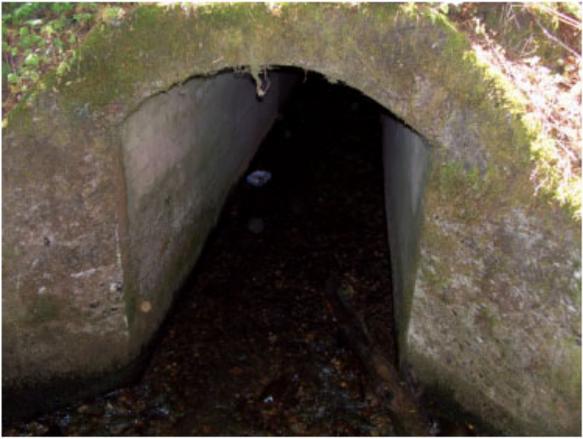
Dairy Creek Road Culvert, milepost 6.548

The Dairy Creek Road culvert at milepost 6.548 is currently in the preliminary design phase of replacement and the site may require a bridge rather than a culvert. When completed, the replacement will reopen 4.7 miles of historical salmonid habitat on Plentywater Creek. A previous ODFW assessment designated the culvert as a high priority barrier, adding to the County's desire to remove the barrier.

Mile Post	6.548								
Watershed	Dairy McKay								
Stream Name	Plentywater Creek								
Latitude	45deg42.734'N								
Longitude	123deg03.755'W								
Culvert Key #	3400160154								
County Asset #	1649								
Culvert Information

Shape	Arch								
Material	Cast-in-Place Concrete								
Length (ft)	54								
Width (ft)	4								
Height (ft)	6								
Outlet Perch (ft)	0.67								
Slope	2.22%								
Channel Information									
Upstream Gradient	3%								
Bankfull width (ft)	10.5								
Prioritization Analysis									
Habitat Length (mi)	4.67								
Habitat Quality	8.2								
Barrier Severity	2								
Distance to ESH (mi)	0.0								
Habitat Length Points	4								
Habitat Quality Points	4								
Barrier Points	2								
ESH Points	1.0								
Total Points:	11.0

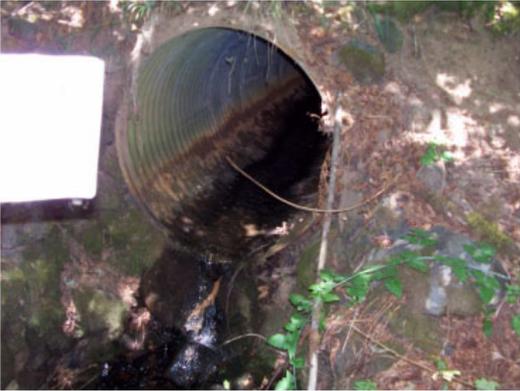
Dairy Creek Road Culvert, milepost 3.827

The culvert at milepost 3.827 is scheduled for replacement during the 2007 construction season and will provide 1.0 mile of upstream habitat. The replacement of both Dairy Creek Road culverts will serve to increase stream connectivity and refuge habitat along the East Fork of Dairy Creek.

Mile Post	3.827				
Watershed	Dairy McKay				
Stream Name	Tributary of East Fork Dairy Creek				
Latitude	45deg40.525'N				
Longitude	123deg03.906'W				
Culvert Key #	3400160148				
County Asset #	1646				
Culvert Information					
Shape	Circular				
Material	Corrugated Steel				
Length (ft)	70				
Width (ft)	3				
Height (ft)	3				
Outlet Perch (ft)	2				
Slope	2.71%				
Channel Information					
Upstream Gradient	1%				
Bankfull width (ft)	7.5				
Prioritization Analysis					
Habitat Length (mi)	0.997				
Habitat Quality	7.5				
Barrier Severity	3				
Distance to ESH (mi)	0.0				
Habitat Length Points	2				
Habitat Quality Points	4				
Barrier Points	3				
ESH Points	0.998				
Total Points:	9.998

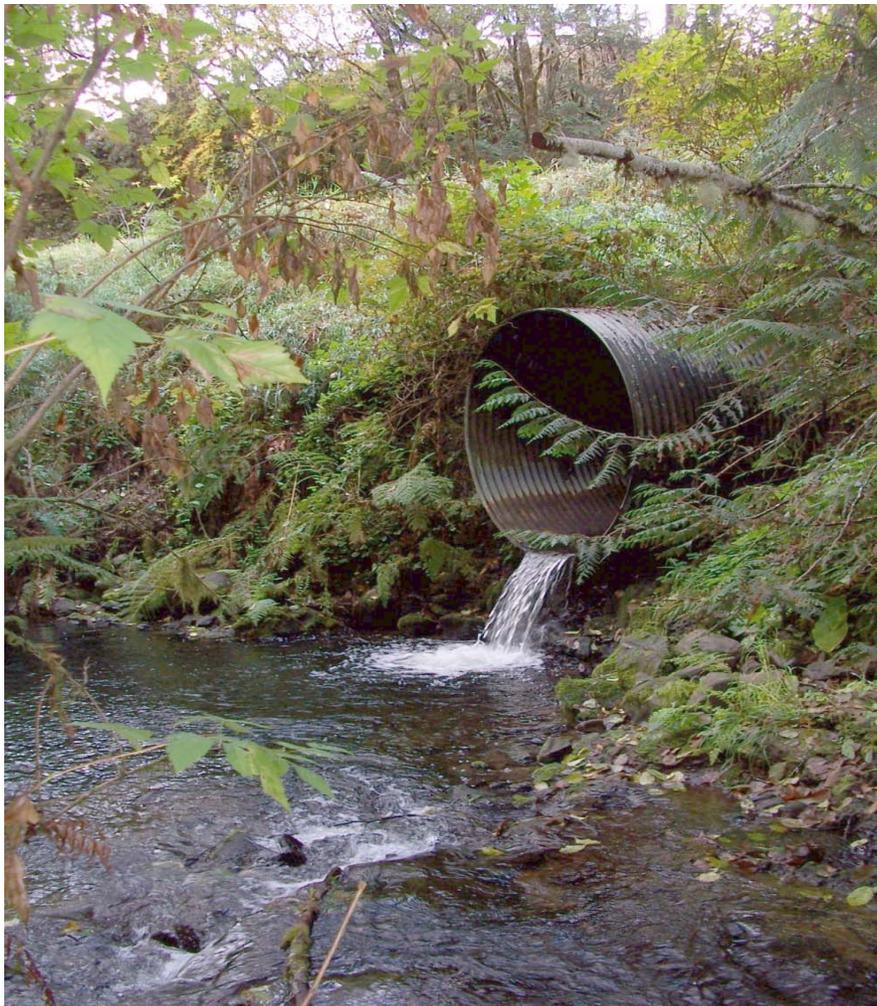
Fern Flat culvert at confluence of E Fork Dairy Creek & Campbell Creek
