Dairy-McKay Fish Passage Assessment and Prioritization

Washington County, Oregon
Department of Land Use and Transportation,
Operations and Maintenance Division

December 2006

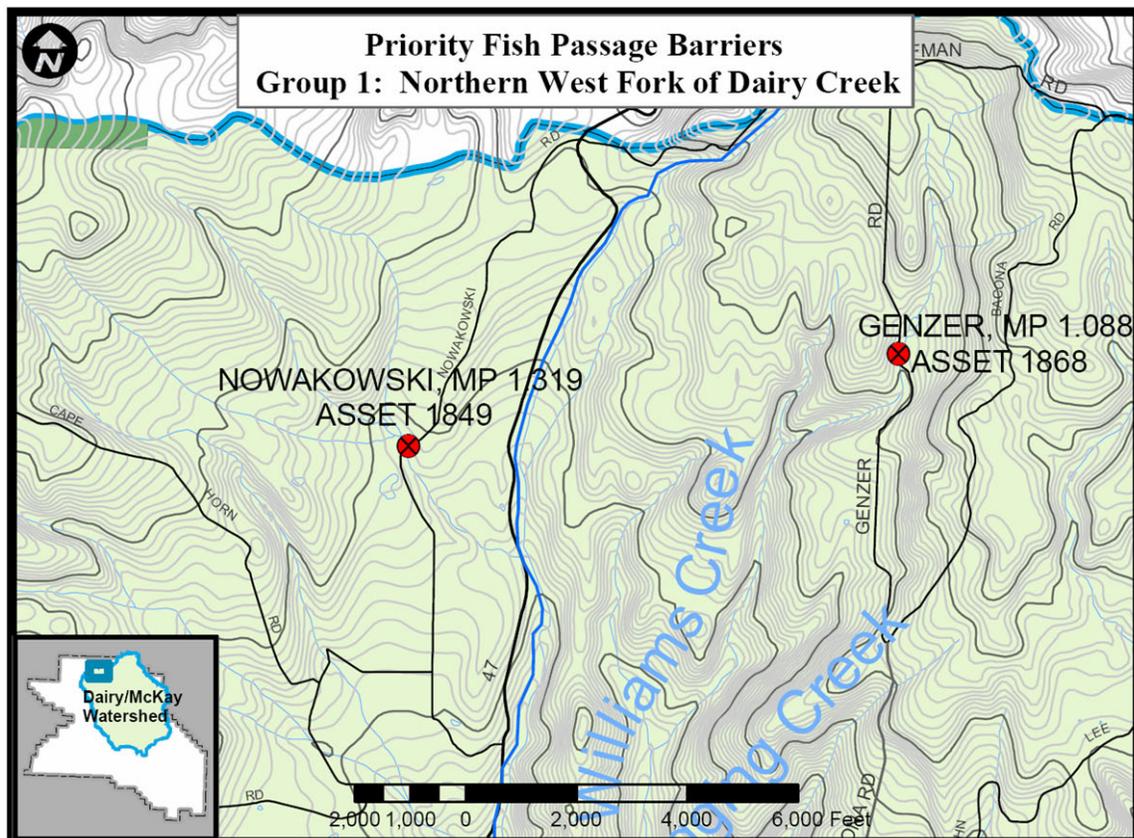
Figure 4 Group 1

Group 1 includes two high-ranking culverts in the northwestern portion of the watershed. Nowakowski Road milepost 1.319 and Genzer Road milepost 1.088, scoring second and third overall, carry high quality streams which flow into the West Fork of Dairy Creek. While not on the same road, these culverts were grouped together because they are present in the same system and could be replaced together in one construction season. If replaced, these culverts would provide access to 5.5 miles of high quality habitat.

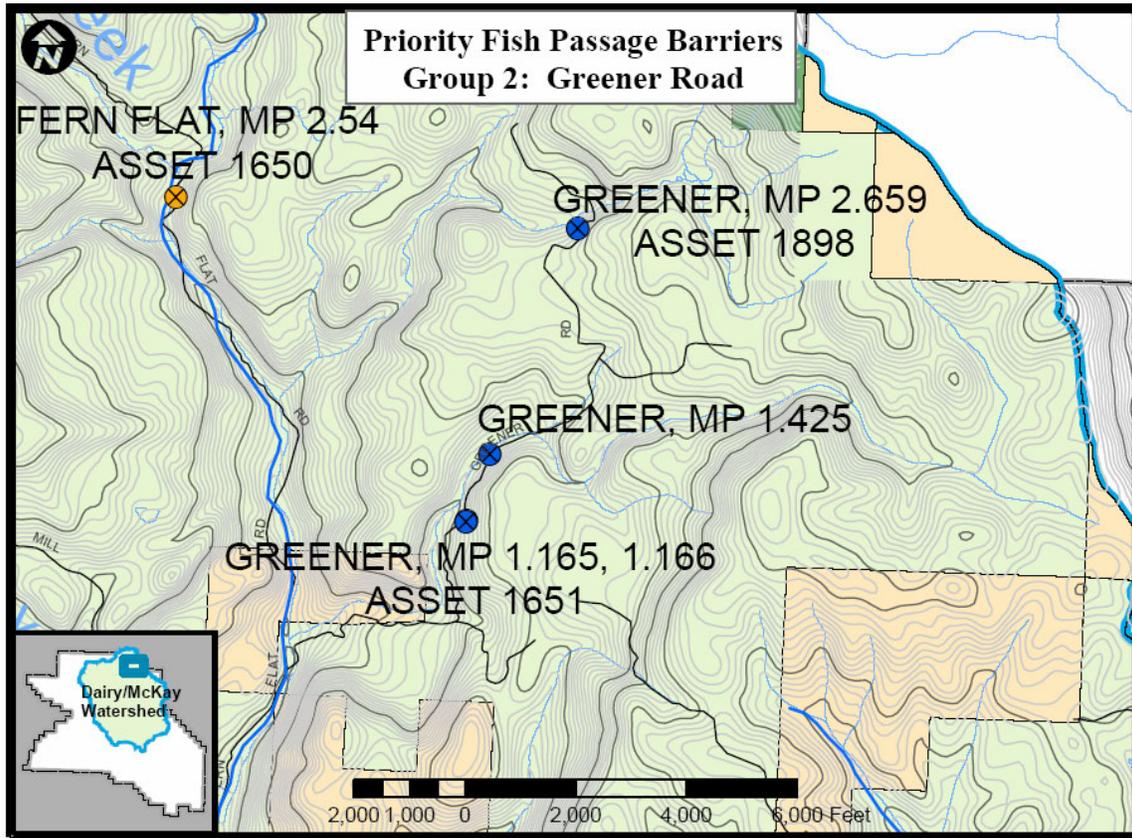
Figure 5. Group 2

Three barriers along Greener Road comprise Group 2 and block access to 7.7 miles of upstream habitat. The dual culverts present at milepost 1.165 carry Rock Creek, a tributary to the East Fork of Dairy Creek, and the culvert at milepost 1.425 carries a small tributary to Rock Creek. The final barrier is further north on Greener road and carries Panther Creek, also a tributary to the East Fork of Dairy Creek. Both Rock Creek and Panther Creek provide high quality fish habitat. Washington County has replaced several fish barriers within the East Fork of Dairy Creek system, and the replacement of these barriers would be a continuation of that work.

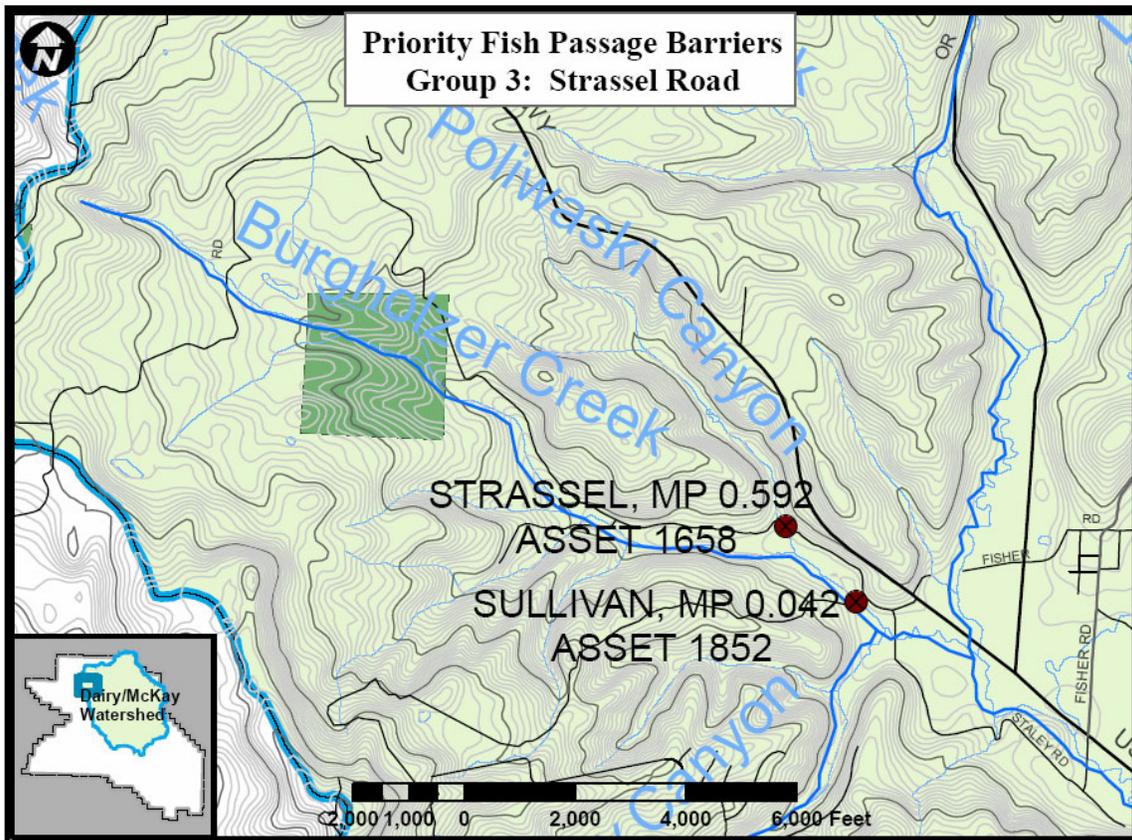
Figure 6. Group 3

Group 3, comprised of the barriers on Sullivan road at milepost 0.042 and Strassel Road at milepost 0.592, bars access to 9.8 miles of upstream habitat. Sullivan Road crosses Burgholzer Creek, an ESH stream, and Strassel Road crosses Poliwaski Canyon Creek, which feeds into Burgholzer Creek 0.136 miles downstream of the barrier. Both streams provide excellent fish habitat. Washington County has another fish passage barrier on Strassel Road upstream of the Sullivan Road barrier that is scheduled for replacement during the summer of 2008. As that barrier will be replaced in the near future, it is not included in the overall barrier ranking report. Replacing the Strassel Road group will further the County’s work to increase the stream connectivity of the Burgholzer Creek system.

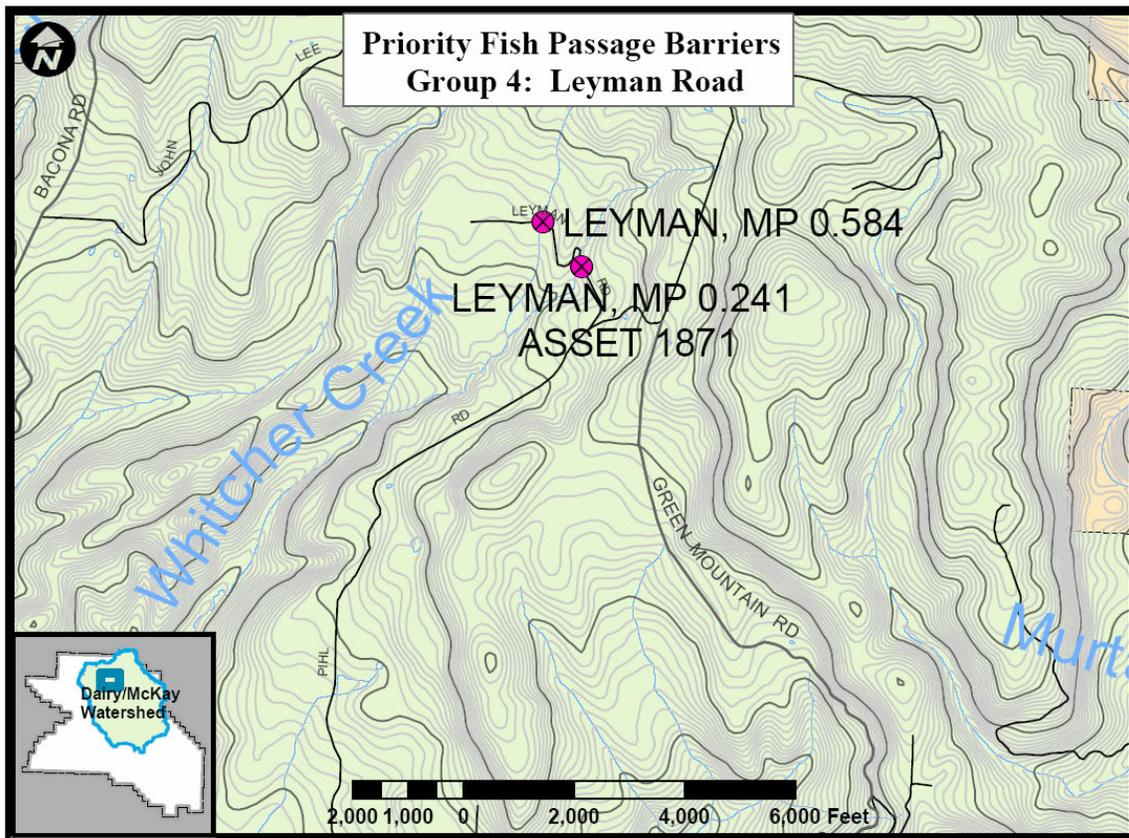
Figure 7. Group 4

The Leyman Road barriers are close together and would be easy to replace at the same time. Providing access to 1.5 miles of upstream habitat, these two culverts are impassable at all flows.

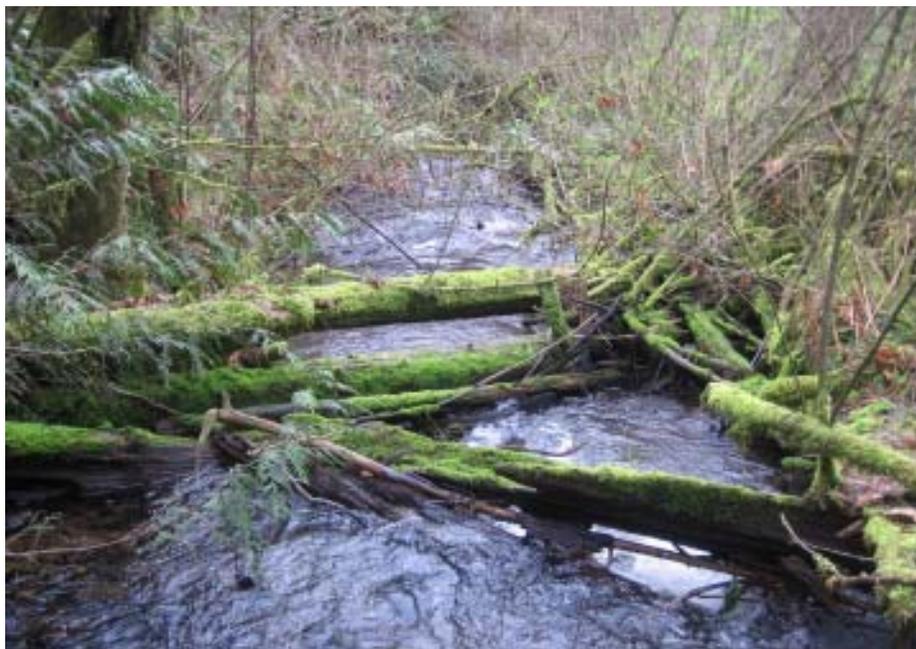
Fern Flat Road Culvert

Typical inaccessible habitat in Dairy-McKay Watershed
